ATF/CFI REPORTS OF INVESTIGATION:

ATF Case Title: Fire 7809 Winans Lake Rd. Hamburg Township, MI. ATF Case Number: 774020-20-0018 Scene Address: 7809 Winans Lake Rd. Hamburg Township, Michigan Dates: December 11, 2019, and December 16, 2019 Reports Authored by: SA/CFI Mike Stassi, (313) 600-1356

Report of Investigation

Title of Investigation:	Investigation Number:	Report Number:
Fire 7809 Winans Lake Rd. Hamburg Township, MI	774020-20-0018	1

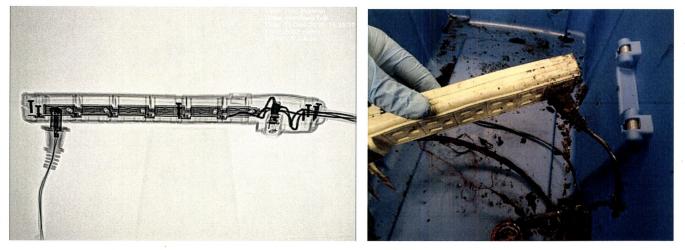
- 3. Upon examining and x-raying the recovered items of evidence, investigators noted that both the power strip and the light fixture were in what appeared to be the "on" position. Furthermore, the affected halogen lamp, which was found secured within the light fixture, was removed, examined and identified as a GE brand 80 watt/120 volt halogen bulb. Comparison examinations of the fire damage, sustained by the noted electrical items, revealed the presence of both thermal and smoke exposure damage. Furthermore, review of the fire scene photographs, documenting the placement of the cloth materials and pan of oil, indicate that these combustibles were positioned near the light fixture to intentionally set a fire.

X-RAY IMAGES AND PHOTOGRAPHS OF THE RECOVERED POWER STRIP

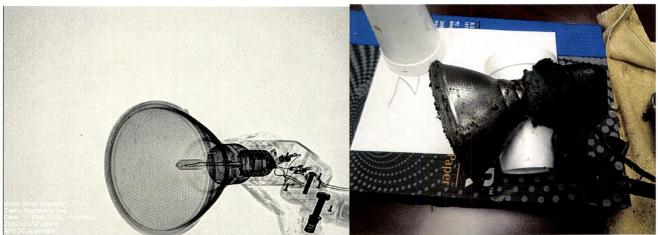
X-RAY IMAGES AND PHOTOGRAPHS OF THE RECOVERED LIGHT FIXTURE
